To:	Gordon Easton	From:	Russell Warren, P.Eng.
Cc:	Jason Wegman	Date:	May 25, 2016
Project Title:	Block F	File No.:	12-125
Re:	Tree Survey Methodology

Diamond Head Consulting Ltd. Tree Management Recommendations for 1266 UEL Block 6

Civic address: 1266 UEL Block F

Date of site visits: Nov 21, Dec 6 2012/March 14,April 5 2013/August 10 2014/April 3 2015

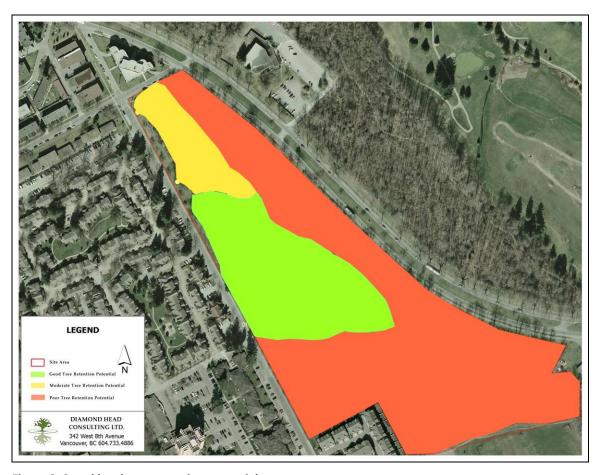
Figure 2. Stand level tree retention potential

The five stands of trees on this site were placed into the following categories for tree retention opportunities. Figure 2 illustrates the locations of these tree retention areas.

<u>Poor:</u> These stands include trees that could not be retained safely adjacent to any development. The trees in these stands have structural characteristics that if exposed on their own would make them prone to windthrow in high wind events. The failure potential of these trees once exposed is likely during wind events that reach speeds of greater than 40km/hr.

<u>Moderate</u>: These stands include individual or small groups of trees that could be exposed on their own. Some of these trees would require feathering prescriptions to make them more windfirm. The failure potential of some of these trees is possible during wind events that reach speeds of greater than 40 km/hr.

<u>Good</u>: These stands provide individual and groups of trees that could be safely retained. After windfirming treatments it is expected that they will be stable. There is a low risk of windthrow during unusually high wind events. The failure potential of some of the exposed trees is unlikely during wind events that reach speeds of greater than 40 km/hr.

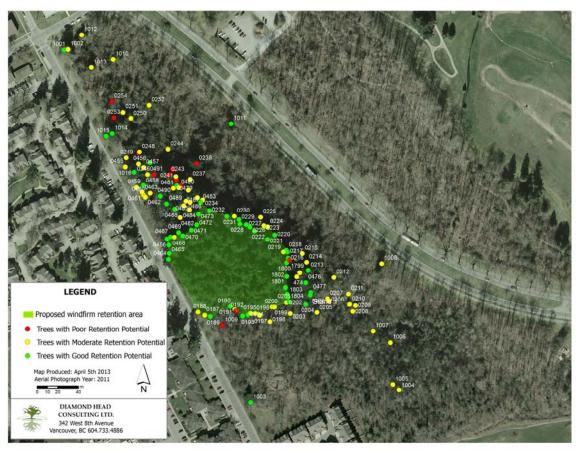
Figure 3. Tree retention potential overview map

Following the initial stand assessment, a more detailed tree survey was completed which focused on the identification of a windfirm boundary around Stand 1. This tree survey was carried out with the intention of preserving the windfirm edge trees that have established around its perimeter. In addition to these edge trees, significant trees outside of this core retention zone were also identified for possible retention.

Trees were assigned a retention potential value (Good, Moderate, Poor) based on the health and structural stability of the tree, and its ability to adapt to changes in growing conditions such as hydrology and removal of neighboring trees.

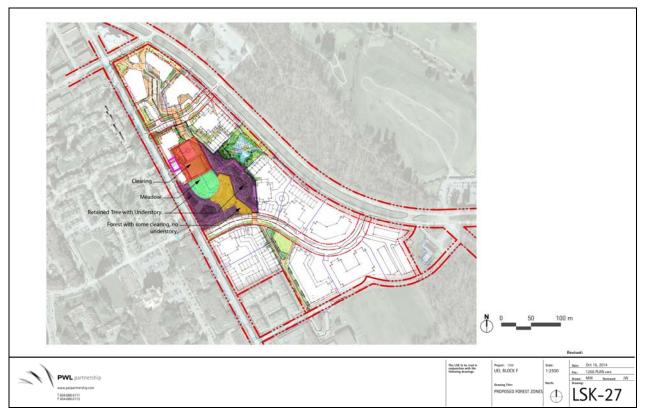
Figure 4 – Forest management zone concept (PWL, 2014)

In 2014 land use planning proceeded with the intention of retaining the majority of Stand 1 as an intact stand of mature conifer trees. DHC completed a detailed assessment of this stand to identify options for the installation of an open passive meadow area. It was found that this could be established as long as the opening is limited in size and protects the most windfirm trees in the area. A suitable treed boundary was identified and subsequently surveyed. This opening extends south-east from Acadia Road. It is critical that a natural edge (4-6m) be established around the perimeter of this meadow area to ensure that the rooting zones of the edge trees remains undisturbed.

To the north of this meadow area, a clearing is proposed which would support scattered large trees. Individual dominant trees have been identified for retention in this area. These include the largest Douglas-fir trees. Lower crowns of these trees can be raised to about 30m to allow for light to reach the clearing area. A no disturbance zone is required around these individual trees to keep them healthy and windfirm.

To the southeast of the meadow zone, a view corridor will be established. In this area, all mature trees will be retained, however shrubs and understory trees will be pruned down to allow for visual sight lines. With the exception of trails, no ground disturbance is allowed to protect the roots of mature trees in this area.

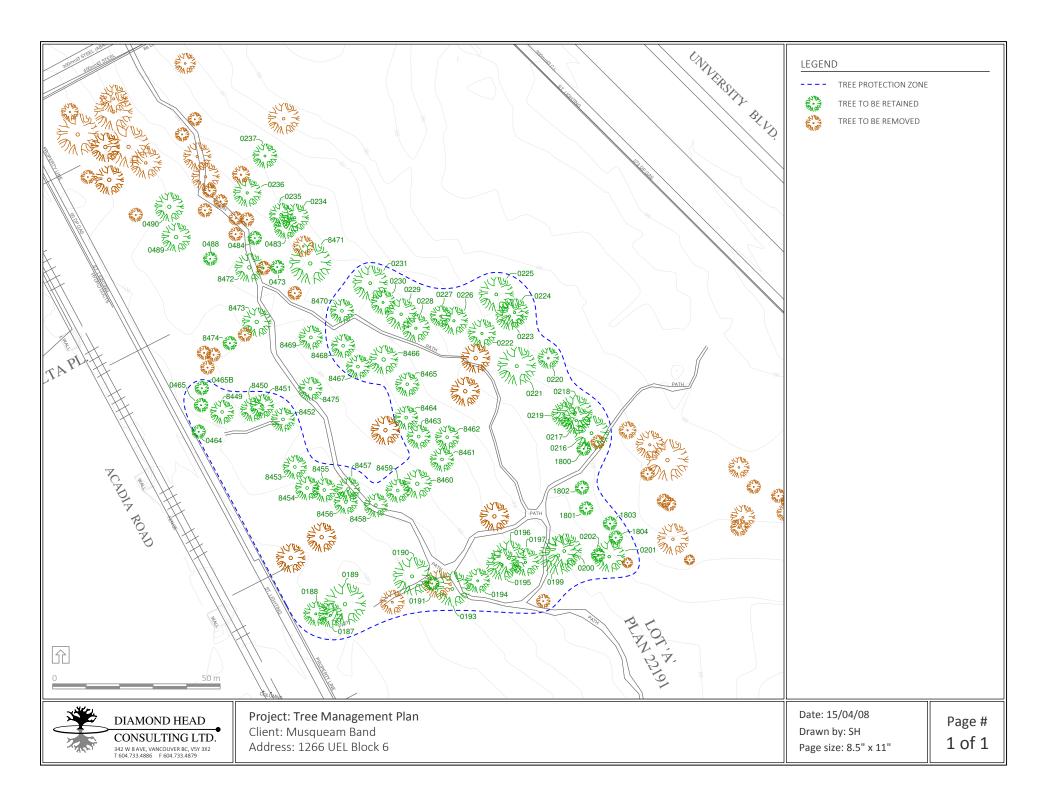
A completed inventory of trees that will form the outer edge of Stand 1 as well as the inner edge of the meadow area are summarized in Table 1. This table also includes the individual trees that are proposed for retention in the clearing area north of the meadow. Tree locations are illustrated in Figure 5.

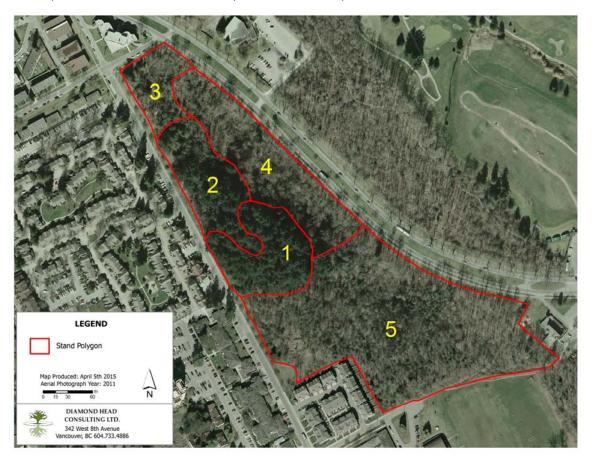
Figure 6. Stand Polygons

The site has been divided into 5 stands based on tree characteristics and the proposed tree retention on site. Stand 1 will retain all mature trees. Stand 2 will retain selected dominant and healthy trees within a cleared park area. Stands 3, 4 and 5 have poor tree retention potential and will be cleared of all trees.

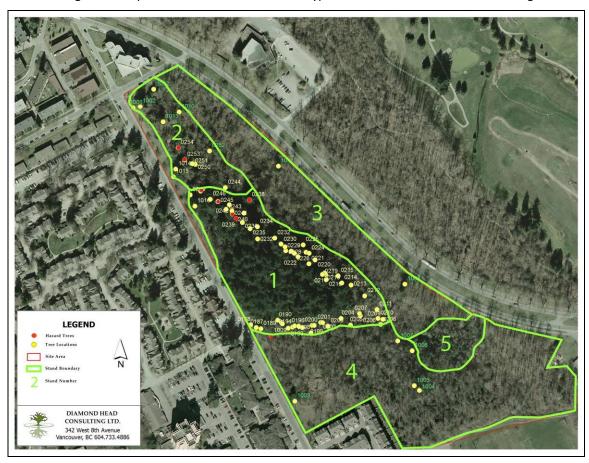
Figure 7. Stand and Tree Inventory

The proposed development area has been divided into five distinct stands. In the middle of the site along the western edge, adjacent to Acadia Road, there is a mature conifer stand that provides the best opportunity for safe tree retention. The remainder of the site consists of mostly young to intermediate aged deciduous trees growing on sites with high moisture regimes. With the exception of a number of scattered conifer trees, these other stands provide poor opportunities for safe tree retention. The following is a description of each of the five stands types. Their locations are illustrated in Figure 7.
