Diamond Head Consulting Ltd. Tree Management Recommendations for 1266 UEL Block 6 (Updated)

August 20th 2013

Civic address:	1266 UEL Block F
Project No.:	N/A
Client name:	Colliers International
Date of site visit:	Nov 21, Dec 6, 2012, and March 14, April 5, 2013

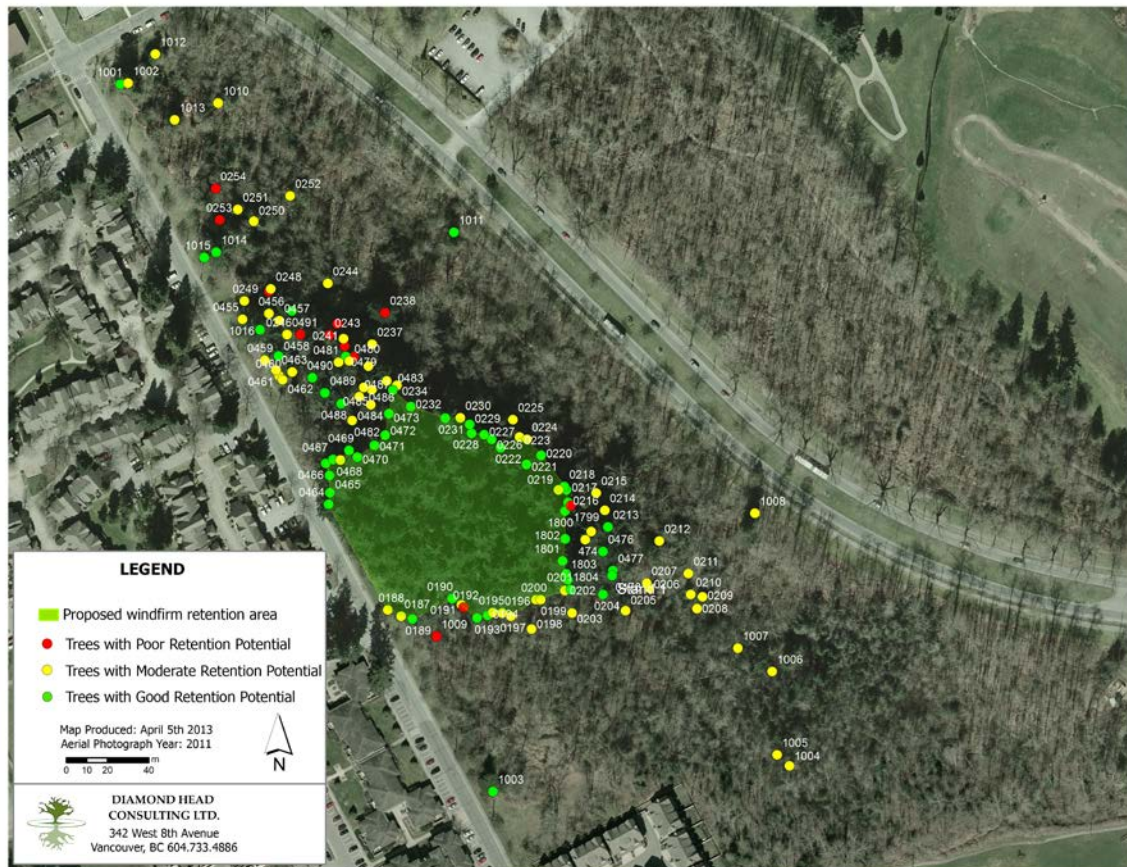
Figure 2. Tree retention potential overview map

Many of the edge trees for the retention area of Stand 1 were given a good retention potential. A windfirm boundary was laid out in consultation with the proposed development plan (See Figure 3). Large dominant Douglas-fir trees were given a retention potential of Good as they are well rooted and have the ability to adapt well to disturbance. There were some significant trees, away from Stand 1 on the west edge of the site, that are recommended to be considered for retention. In particular there are large windfirm Douglas-fir growing north west of Stand 1 that should be considered for individual retention. Particular attention should be paid to the mature Douglas firs with tag numbers **1014**, **1016**, and **0458**.

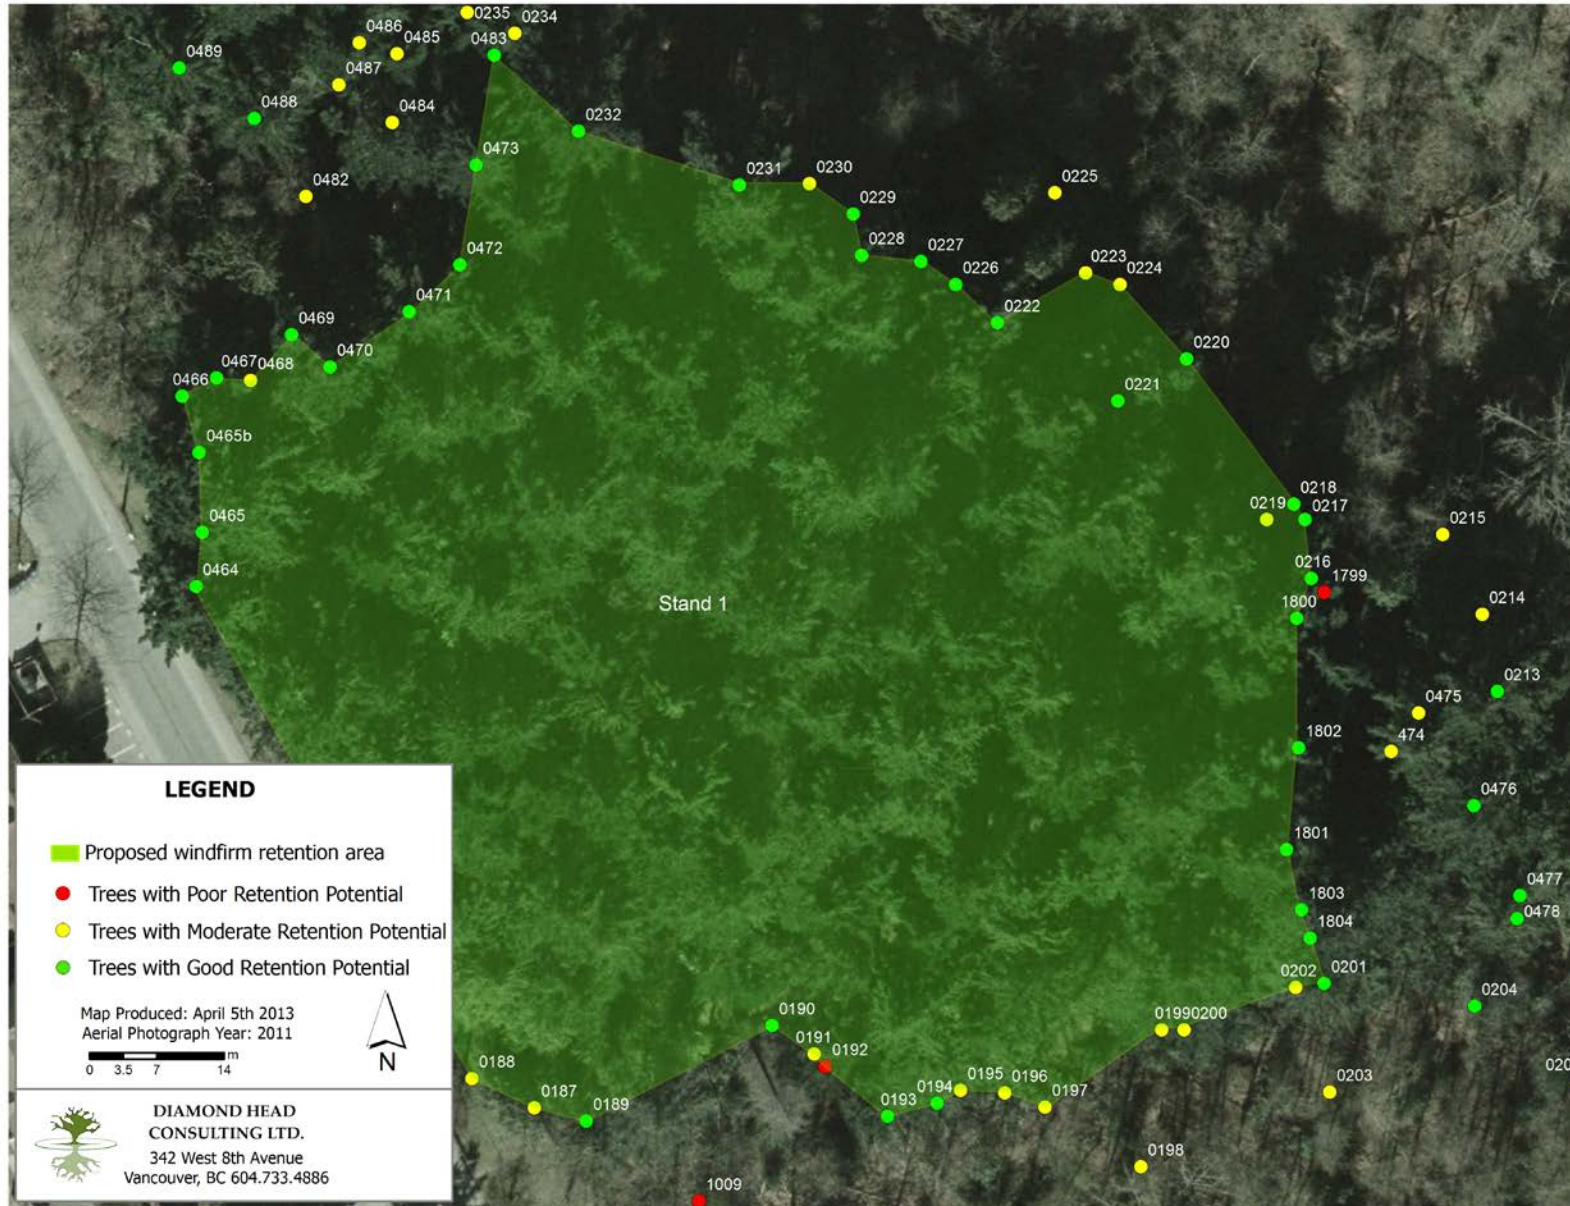
Figure 3. Detailed tree retention map (tree locations are approximate and a survey will be required before actual boundary is established)

In conjunction with tree inventory information, site visits and consultation with the proposed development plan, DHC has recommended the best possible windfirm boundary. The proposed boundary has been mapped in Figure 3. It should be noted that the tree locations on this map are approximate and a survey of the tagged trees should be done so that a map including the root protection zone (RPZ) can be produced.

In these areas, the best available boundary has been chosen along the assessment area however in many cases, there are no obvious options and hazardous trees will be exposed. These hazardous trees must be removed and the edge trees must be feathered to reduce the chance

of failure in the edge tree to be retained. This feathering prescription includes pruning techniques to remove hazardous parts, reducing the height of the crown in deciduous trees and spiral pruning of conifers. Spiral pruning involves the removal of branches throughout the crown such that the form of the original crown has the same shape, but is more open to allow wind to pass through. This treatment should aim to reduce crown density by 20%-40% evenly distributed throughout the crown.
