Diamond Head Consulting Ltd. Tree Management Recommendations for 1266 UEL Block 6

April 8th 2015

Introduction

Civic address:	1266 UEL Block F
Project No.:	N/A
Client name:	Colliers International
Date of site visits:	Nov 21, Dec 6 2012/March 14, April 5 2013/August 10 2014/April 3 2015

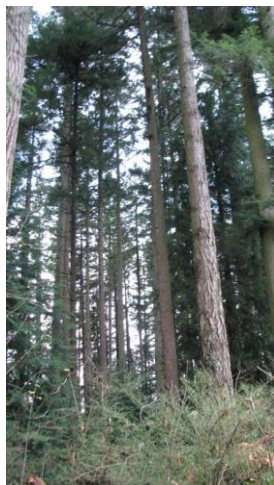
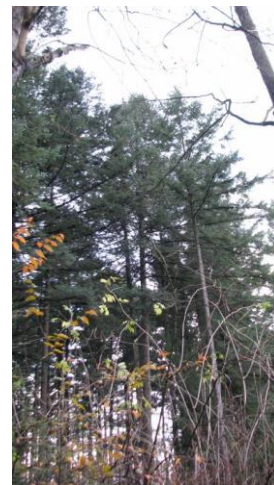
Photos 1 and 2 - Stand 1

This area supports a mature conifer stand that is much older than the rest of the stands on this property. The dominant tree species includes Douglas-fir (*Pseudotsuga menziesii*), with mixed components of western redcedar (*Thuja plicata*) and western hemlock (*Tsuga heterophylla*). Many of these trees are of significance in terms of their size. The largest trees include the Douglas-fir which reach diameters of up to 100cm and heights of up to 50m. These dominant trees are growing on a slightly drier site and have reached a height that is well above the trees on the rest of the property. The trees around the perimeter, although still reliant on the stand for support, are considerably more windfirm than the trees found in the middle of the stand. Trees in the middle of this stand have higher height to diameter ratios and rely upon the stand as a whole to withstand oncoming winds. This stand has grown and adapted together and disturbing or removing trees on its parameter will expose less stable trees making tree retention more difficult. This stand provides the best opportunity for tree retention on the site. The trees area healthy and windfirm as a group. If this entire stand cannot be retained in its entirety, the southern portion should be prioritized for retention. This area supports the greatest number of large windfirm trees.

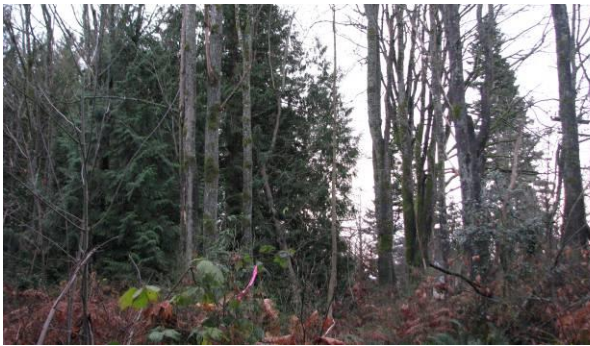
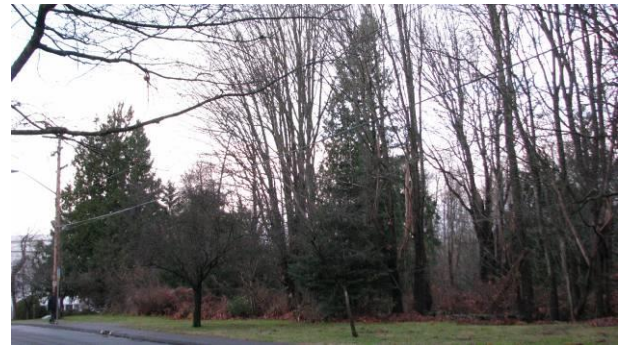
Photos 3 and 4 - Stand 2

The stand is growing in the north west portion of the site adjacent to Acadia Road. It consists of a mix of mostly mature Bigleaf Maples (*Acer macrophyllum*) and western redcedar trees. This site is slightly drier than the areas further to the east. This is a relatively open stand with canopy gaps. There are a number of mature western redcedars growing along the perimeter of the property that are windfirm and provide good opportunity for tree retention. The bigleaf maples generally have structural defects including multiple stems and decay that make them unsuitable for individual tree retention.

This stand provides some opportunity for individual tree retention. Efforts should focus on retaining the mature western redcedars that have been identified around the north and west edges of the stand.

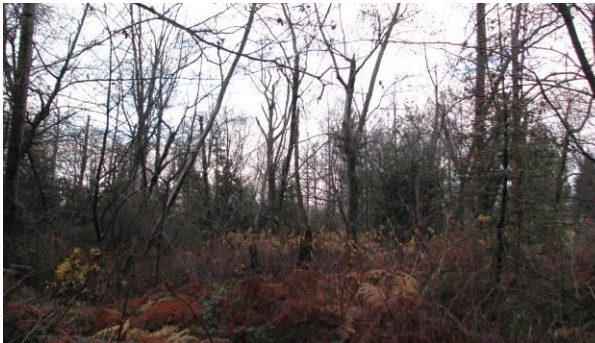
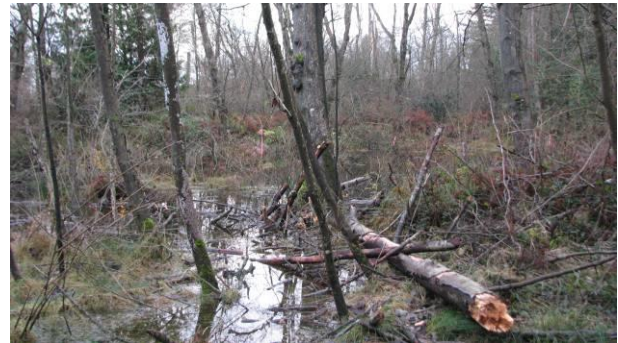
Photos 5 and 6 - Stand 3

This stand consists of mainly of young to intermediate aged Red Alder (*Alnus rubra*) that are growing in an area with a high water table. There are pools of standing water and wetland plant species that indicate that this area remains wet throughout the year. This stand is open with numerous canopy gaps. Many of the trees are showing signs of stress likely related to the high water table. Many have dead or broken tops. There are very few trees that are suitable for tree retention. The possibility for small group or individual tree retention is further complicated by the changes that the new development will have to the water table.

The trees in this area provide poor opportunities for safe retention.

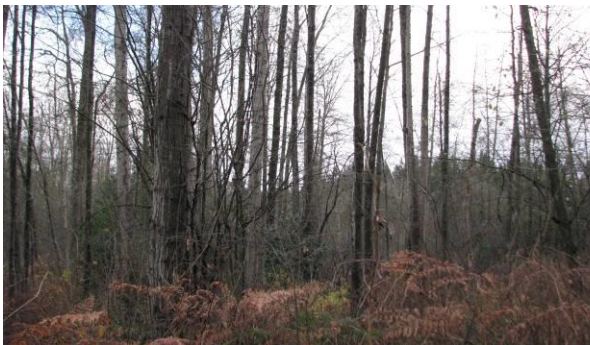
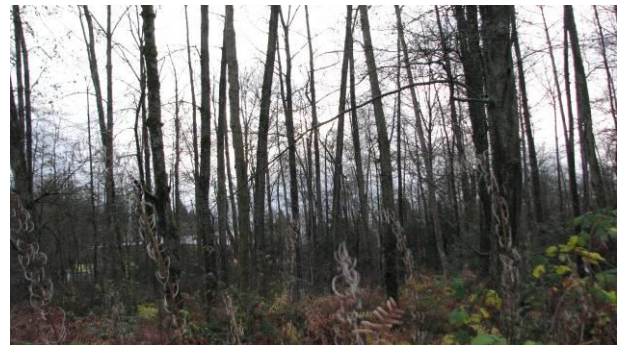
Photos 7 and 8 - Stand 4

This stand consists of mainly intermediate aged Black Cottonwood (*Populus trichocarpa*) and Red Alder (*Alnus rubra*). There are scattered mature western redcedar and western hemlock in the main canopy and in the suppressed layer. The stand is moderately dense and many of the trees have high height to diameter ratios. Most of these trees are healthy, however they have grown together as a group relying on each other for structural support. It would be challenging to ensure the stability of these interior trees if they were exposed on their own.

The majority of the trees in this area provide poor opportunities for safe retention. There are however scattered western redcedar trees in this stand that are growing on slightly drier sites and could potentially be retained on their own.

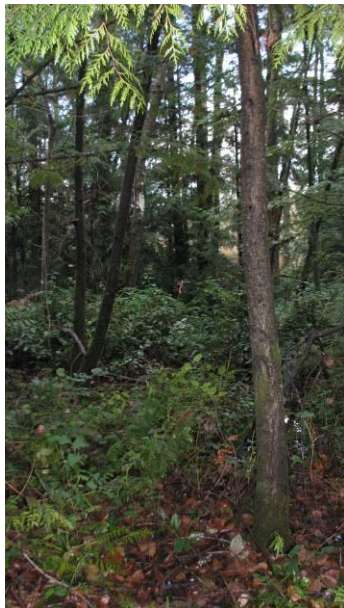
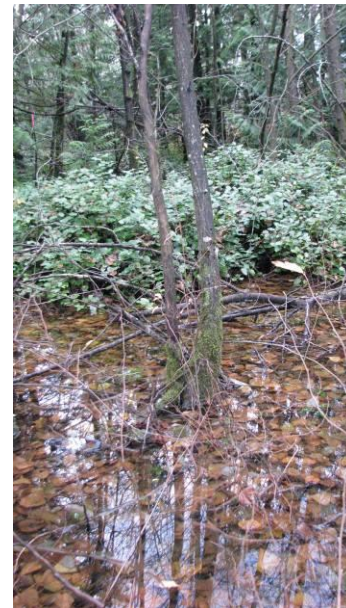
Photos 9 and 10 - Stand 5

This stand consists of mostly western redcedar that are growing on a wet and nutrient poor site. This stand supports smaller trees that are growing at a higher density compared to adjacent areas. There were large standing pools at the time of assessment. Most cedar trees are healthy however, they have adapted to growing on this wet site and have grown shallow rooting systems. It is expected that this groups may go into decline if the water table were altered by the proposed development. There are not trees of significance in terms of their size and species in this area.

The majority of the trees in this area provide poor opportunities for safe retention.
