Diamond Head Consulting Ltd. Tree Management Recommendations for 1266 UEL Block 6

April 8th 2015

Introduction

Civic address:	1266 UEL Block F
Project No.:	N/A
Client name:	Colliers International
Date of site visits:	Nov 21, Dec 6 2012/March 14, April 5 2013/August 10 2014/April 3 2015

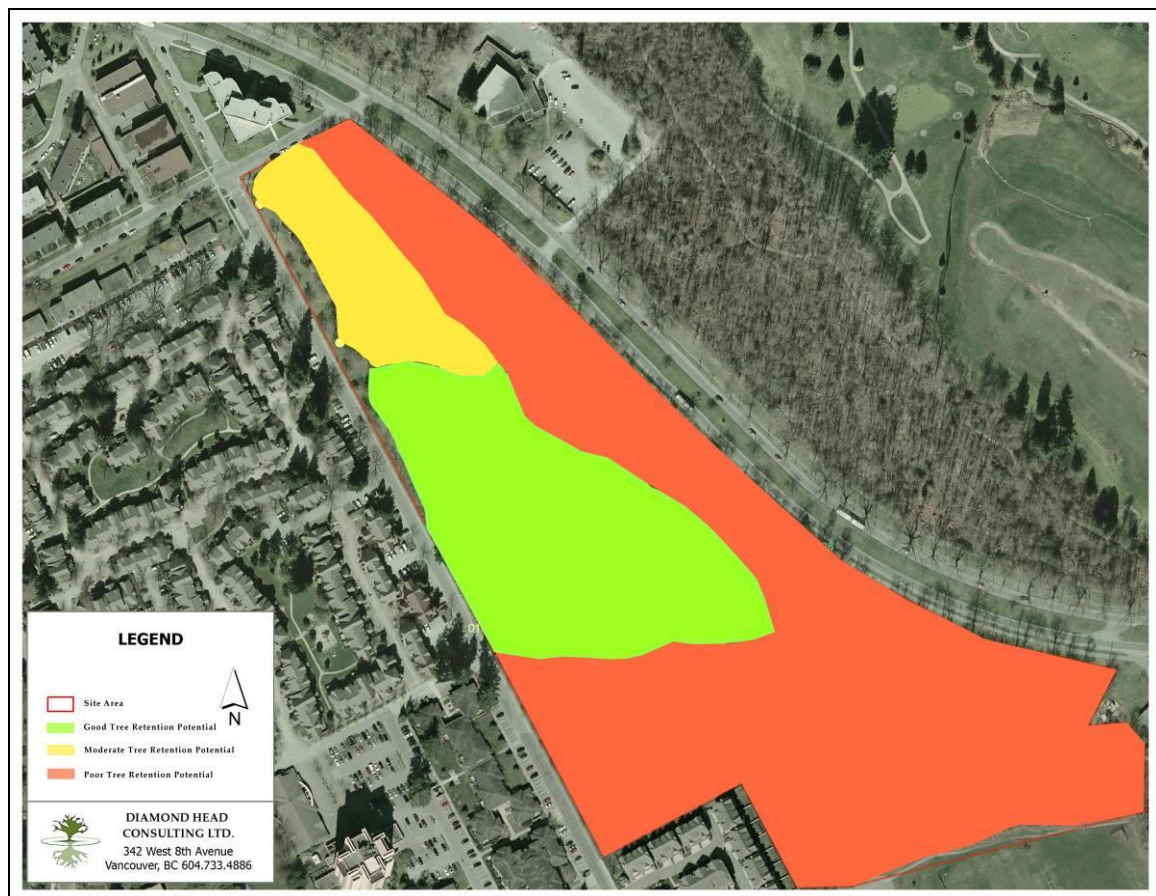
Figure 2. Stand level tree retention potential

Poor: These stands include trees that could not be retained safely adjacent to any development. The trees in these stands have structural characteristics that if exposed on their own would make them prone to windthrow in high wind events. The failure potential of these trees once exposed is likely during wind events that reach speeds of greater than 40km/hr.

Moderate: These stands include individual or small groups of trees that could be exposed on their own. Some of these trees would require feathering prescriptions to make them more windfirm. The failure potential of some of these trees is possible during wind events that reach speeds of greater than 40 km/hr.

Good: These stands provide individual and groups of trees that could be safely retained. After windfirming treatments it is expected that they will be stable. There is a low risk of windthrow during unusually high wind events. The failure potential of some of the exposed trees is unlikely during wind events that reach speeds of greater than 40 km/hr.

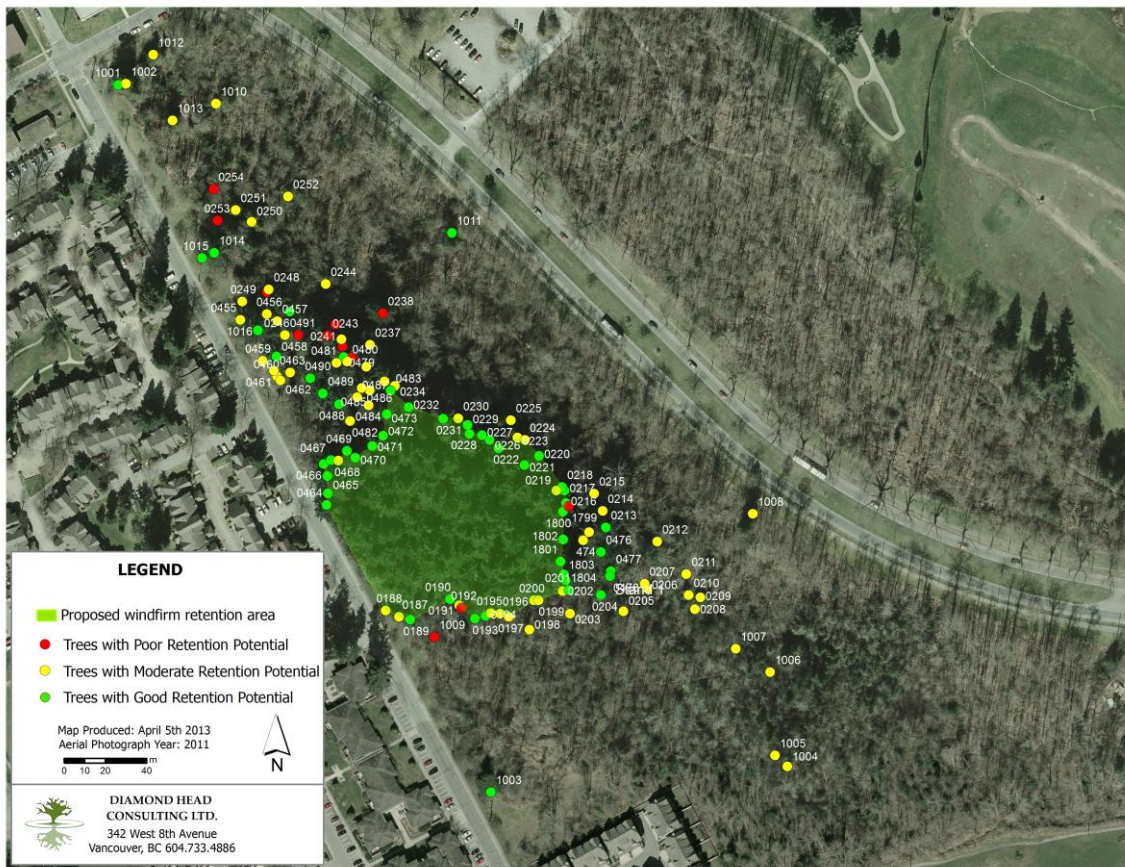
Figure 3. Tree retention potential overview map

Following the initial stand assessment, a more detailed tree survey was completed which focused on the identification of a windfirm boundary around Stand 1. This tree survey was carried out with the intention of preserving the windfirm edge trees that have established around its perimeter. In addition to these edge trees, significant trees outside of this core retention zone were also identified for possible retention.

Trees were assigned a retention potential value (Good, Moderate, Poor) based on the health and structural stability of the tree, and its ability to adapt to changes in growing conditions such as hydrology and removal of neighboring trees.

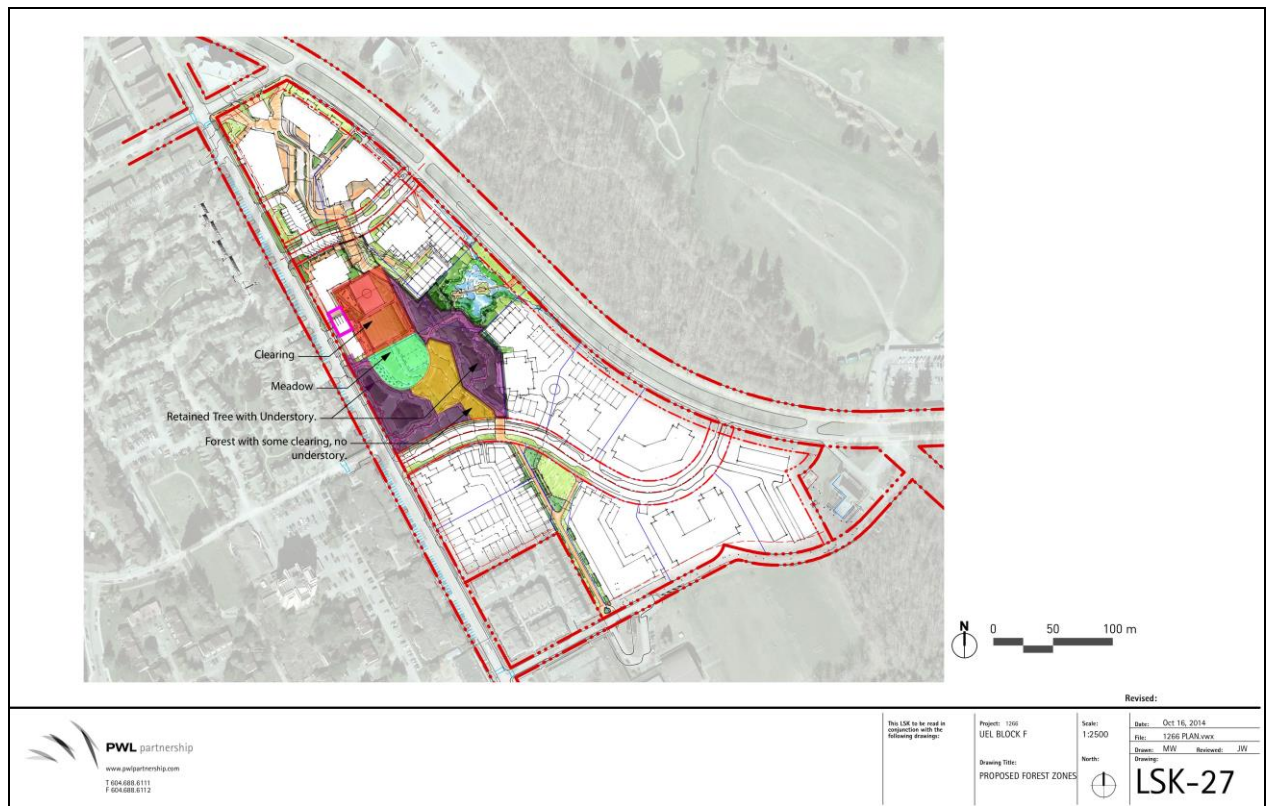
Figure 4 – Forest management zone concept (PWL, 2014)

In 2014 land use planning proceeded with the intention of retaining the majority of Stand 1 as an intact stand of mature conifer trees. DHC completed a detailed assessment of this stand to identify options for the installation of an open passive meadow area. It was found that this could be established as long as the opening is limited in size and protects the most windfirm trees in the area. A suitable treed boundary was identified and subsequently surveyed. This opening extends south-east from Acadia Road. It is critical that a natural edge (4-6m) be established around the perimeter of this meadow area to ensure that the rooting zones of the edge trees remains undisturbed.

To the north of this meadow area, a clearing is proposed which would support scattered large trees. Individual dominant trees have been identified for retention in this area. These include the largest Douglas-fir trees. Lower crowns of these trees can be raised to about 30m to allow for light to reach the clearing area. A no disturbance zone is required around these individual trees to keep them healthy and windfirm.

To the southeast of the meadow zone, a view corridor will be established. In this area, all mature trees will be retained, however shrubs and understory trees will be pruned down to allow for visual sight lines. With the exception of trails, no ground disturbance is allowed to protect the roots of mature trees in this area.

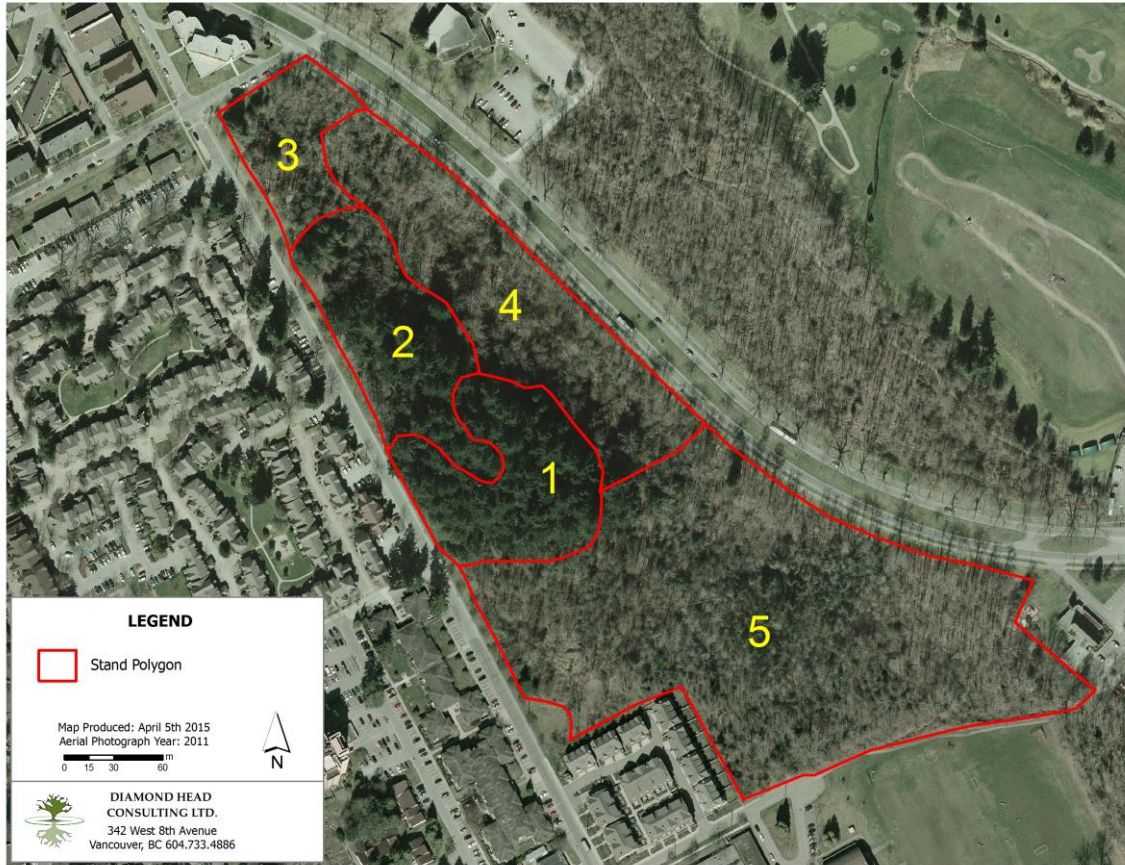
Figure 6. Stand Polygons

The site has been divided into 5 stands based on tree characteristics and the proposed tree retention on site. Stand 1 will retain all mature trees. Stand 2 will retain selected dominant and healthy trees within a cleared park area. Stands 3, 4 and 5 have poor tree retention potential and will be cleared of all trees.
